NuMI Beam Line
Beryllium Vacuum Window

FESHM Chapter 5033.1
Engineering Note

**Vacuum Window Engineering Note
(per Fermilab ES&H Manual Chapter 5033.1)**

Vacuum Window Number: Numi MB-422562

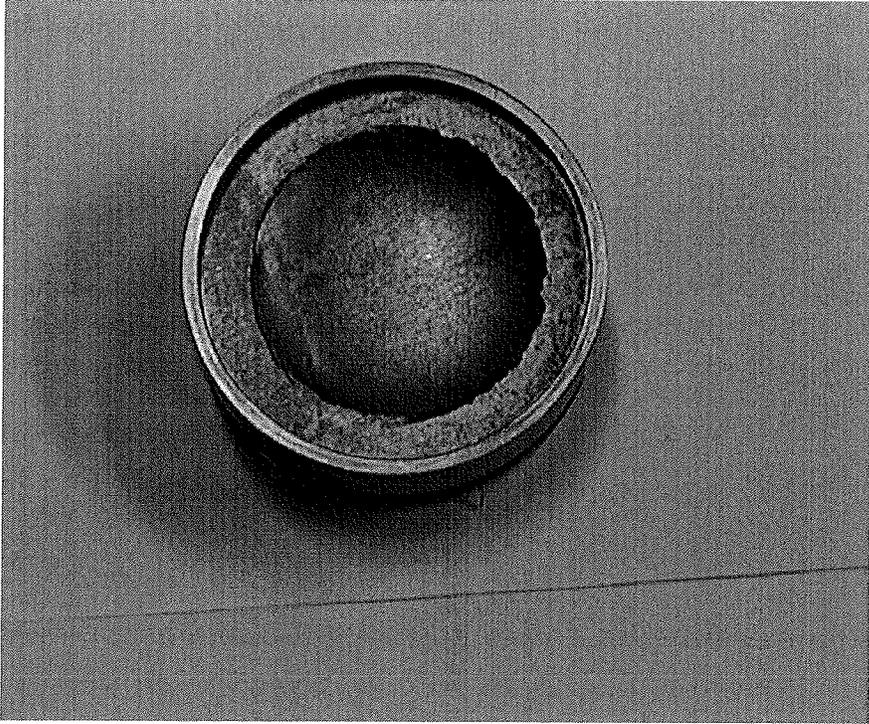
The window failed at a pressure of 160 psig. The deflection was measured to see how well it matched the theoretical calculations. The actual window had an initial deformation of the window of approximately .020”. This deformation comes from the brazing operation of the manufacturing process. Typically the dishing or performing of a window reduces the stresses for a given load. This is consistent with the failure being higher than calculated and the deflection per load being approximately half of the flat disc calculations. The failure of the window at the outer edge at the braze interface is consistent with the calculated higher stresses at the edge.

The failure was instantaneous. See following photo for view of failure.

The circumferential crack has a radius of .56 in. This is approximately where the relief on the window body begins and the braze joint ends. The beryllium slug was still attached and could not be removed.

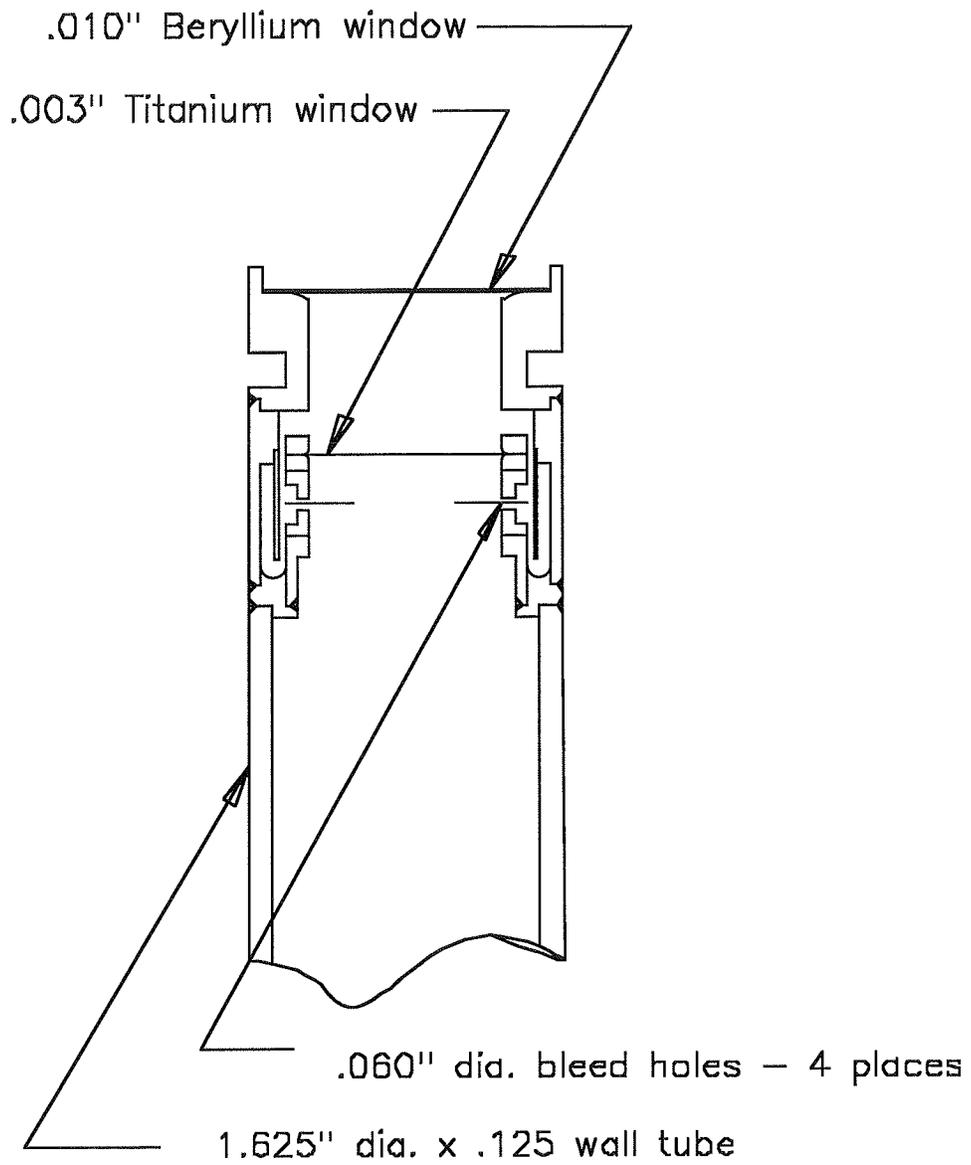
Fig. #2

For a catastrophic failure of a window, an unimpeded burst would likely travel into the Main Injector before the isolation valves had a chance to close. The possibility of beryllium contamination reaching the Main Injector would exist. Most contamination would be generated by larger pieces fragmenting as they are carried down the beam tube. The NuMI Beryllium/Titanium design has a titanium window less than an inch upstream from the beryllium window. This backup titanium window will act as a barrier preventing a burst of air with window fragments from traveling up the beam tube toward the Main Injector. Only the small volume between the windows will travel past the failed window. This volume is less than a cubic inch. The volume between the two windows communicates with the beam tube vacuum through 4 small bleed holes. See Fig. 2

To further reduce flow velocities, the bleed holes will have check-valve-flaps installed over the openings so that in the event of a beryllium rupture the flap will close off the flow passage to the majority of the air flow. The measured flow through the 4 bleed holes is approximately .12 cu. ft./min. The closing speed of the isolation valves is 5 sec. giving a total influx of only 16 cu. in. of air. Any small dust size particles will travel with the air bleeding in through the bleed holes. The first isolation gate valve for the vacuum line is approximately 400 feet upstream of the window. The valves close when ion pumps trip off from high current. The high current is sensed when molecules travel to the first set of pumps. It will take less than a second for the pumps to trip off and start the valves closing. With the first isolation valve closed it will take over 2 hours for this first section to be let up to atmosphere. This slow bleed up will have low air velocities and subsequently will not have enough energy to move particulate up the 15% slope of the beam line.
